# BACKUP INFORMATION

**STS-108  
IN-FLIGHT ANOMALIES  
BACKUP**

<b>STS-108-V-01 and 02: RCS THRUSTERS R4U AND F3F FAILED OFF</b>	Presenter:
	Organization/Date: Orbiter/02-14-02

**STS-108 IMU-2 Z-AXIS/REDUNDANT  
RATE ANOMALY**

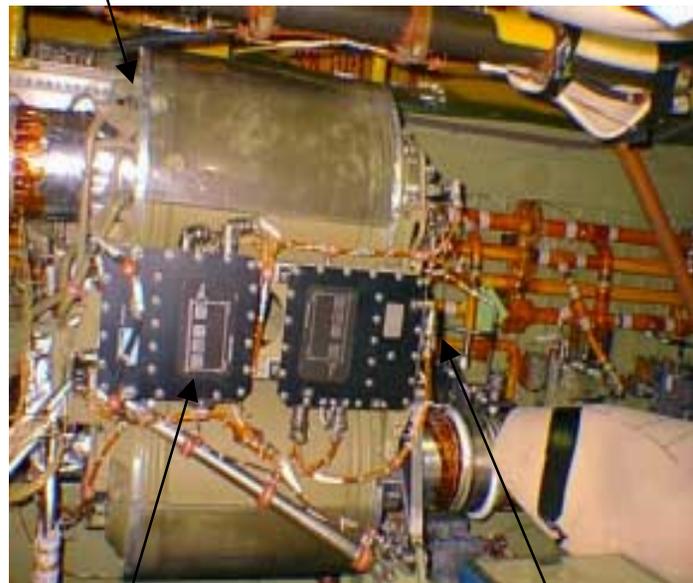
- Post-flight troubleshooting of OV-105 FES isolated the secondary mid-point temperature sensor as the cause of the STS-108 anomaly
  - Controller functional test performed with nominal results
  - Steady state reading of the sensor was within 0.25°F of the two primary sensors
  - However, transient (ramp) test showed a 2-second lag
    - Previous experience indicates loss of thermal conductivity of packing
  - Sensor R&R is planned for February 12th, to be completed by end of week
- Newly refurbished FES is installed in OV-102 at OMM
  - Successfully passed ATP testing
    - All controllers & control modes verified in ATP
  - OMRSD test complete with no open issues

Mid Point Temp Sensor

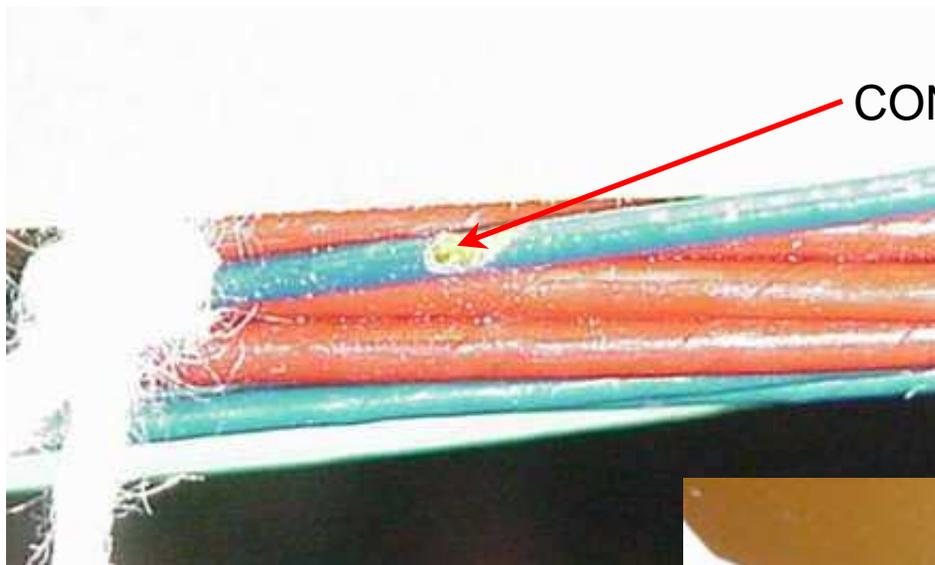
CONDUCTOR DAMAGE

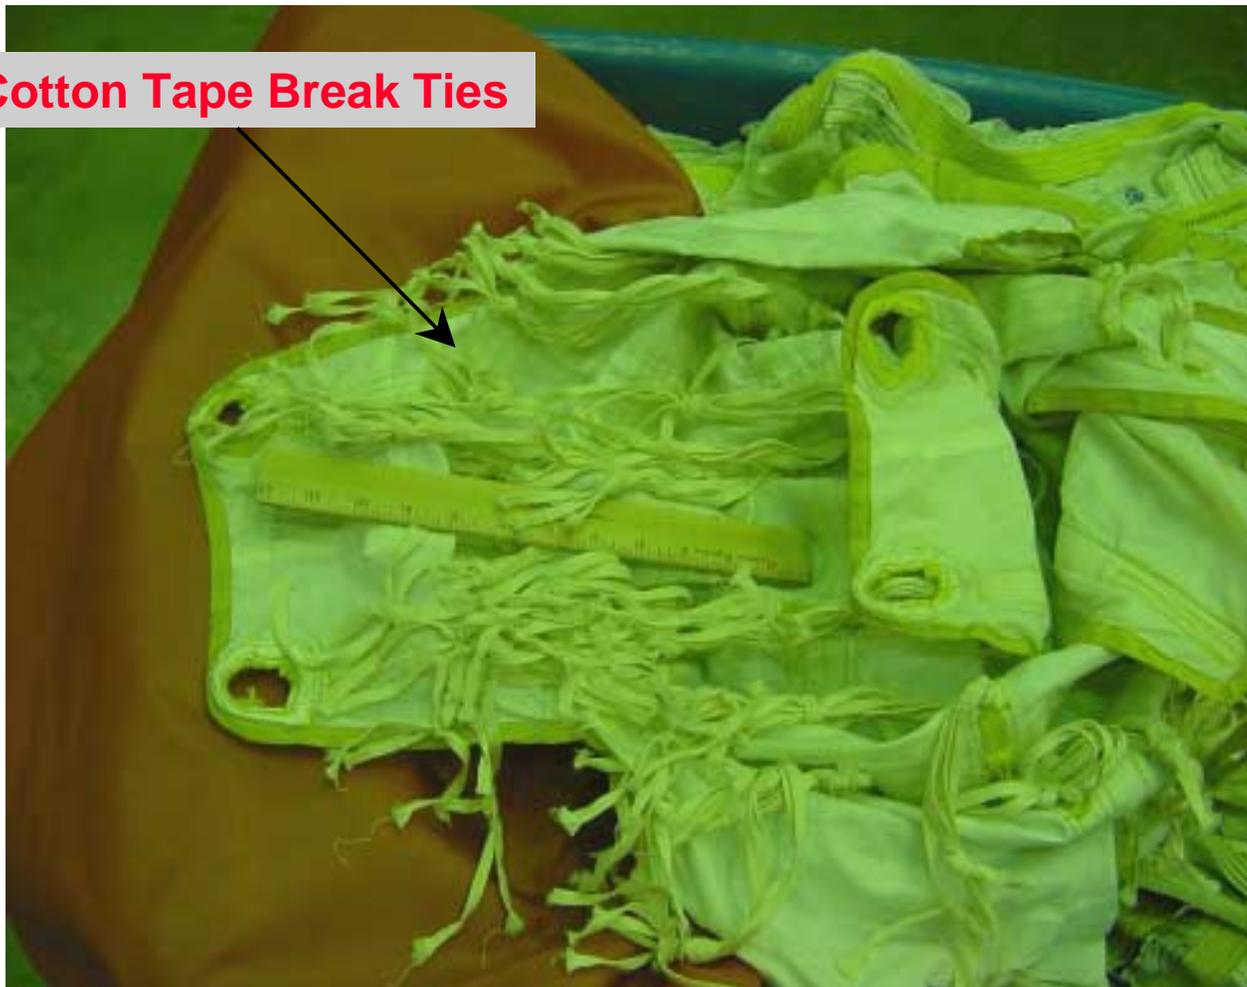
**80 Lb Cotton Tape Break Ties**

- Possible entanglement with 80 lb cotton tape break line ties in bag during canopy deployment
  - 300 lb nylon chute ribbon broken, inspection of break ties revealed no signs of unusual damage
- Possible contact with Teflon flaps in deployment bag during canopy deployment
  - Inspection of flaps revealed no mechanism for snagging
- Review of packing process at PRF indicates damage caused from packing is unlikely
  - First press of canopy does not occur until location of damaged area is well into the pack and compartment contains nothing to snag on
  - Detailed inspection process in place during packing procedure

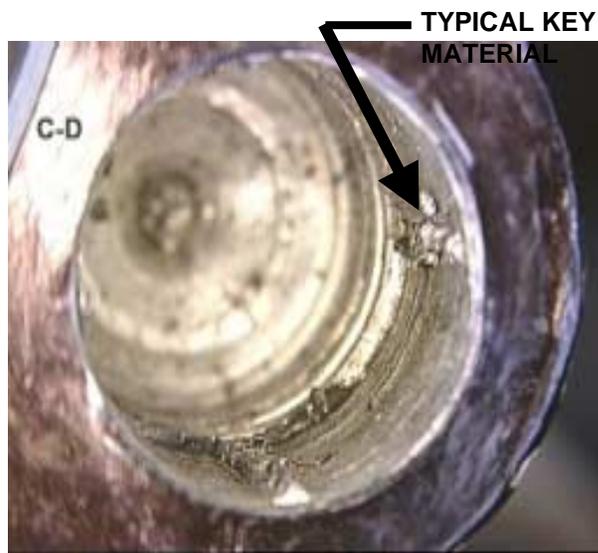
- Pull tests performed on 3 inserts of engineering test unit pump showed that threads in the housing completely sheared out of the hole leaving four keys behind:
  - 10,925 lbs
  - 11,340 lbs
  - 11,586 lbs

STRIPPED HOLE WITH KEY MATERIAL
